Manhole Inspection Summary

Manhole # S55I__038MH

Insp Date: **5/28/08 2:09 PM**

Location Address: **side of 3517 eastern ave**

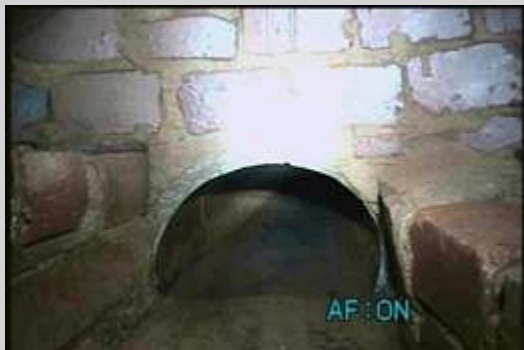
12 O'Clock Outflow

8 in. Circular Gravity Sewer
Pipe Out @ 12 O'Clock

Pipe Material: **Clay** ☐ Pipe Lined

Invert Depth: 11.78 (ft.) Flow Characteristics: **Slow**

Deposits: ☒ None ☐ Mud ☐ Sludge ☐ Debris ☐ Grease

Infiltration: **None** Pipe Seal Cond: **Unknown**

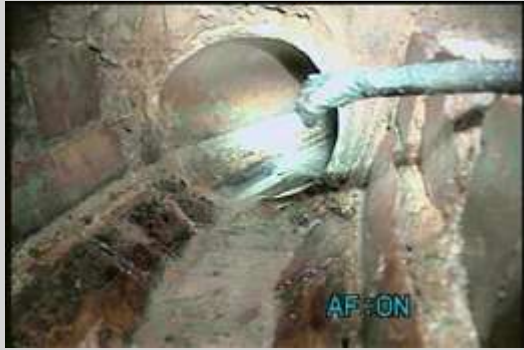
6 O'Clock Inflow

8 in. Circular Gravity Sewer
Pipe In @ 6 O'Clock

Pipe Material: **Clay** ☐ Pipe Lined

Infiltration: **None**
